Installation of the RS-232 Citel Surge Protection Device

For many years, the I/O Silver Board has served as the Surge Protection Device (SPD) between the FuelMaster® Unit (FMU) and external devices, such as tank monitors. We have found that the Citel DLAS-12D3 SPD is a more effective means of limiting surge damage for RS-232 connections.

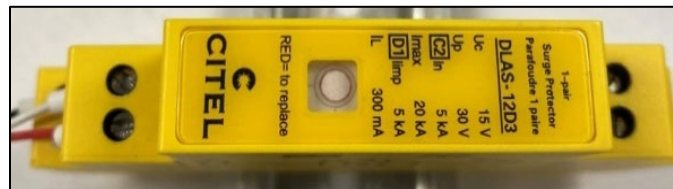
Figure 5 The Replacement Popper

- The SPD features a red replacement popper on top (Figure 5). If the SPD fails, only the module needs to be replaced. Order a replacement using the chart in the [Parts Listing Section](#). To replace, pull the failed module up and swap in the new module (Figure 6).
